ANNUAL REPORT FOR 2000

**Dismal Swamp Mitigation Site
Gates / Perquimans County
Project No. 6.129003T
TIP No. R-2208 WM**

Prepared By:
Natural Systems Unit & Roadside Environmental Unit
North Carolina Department of Transportation
December 2000

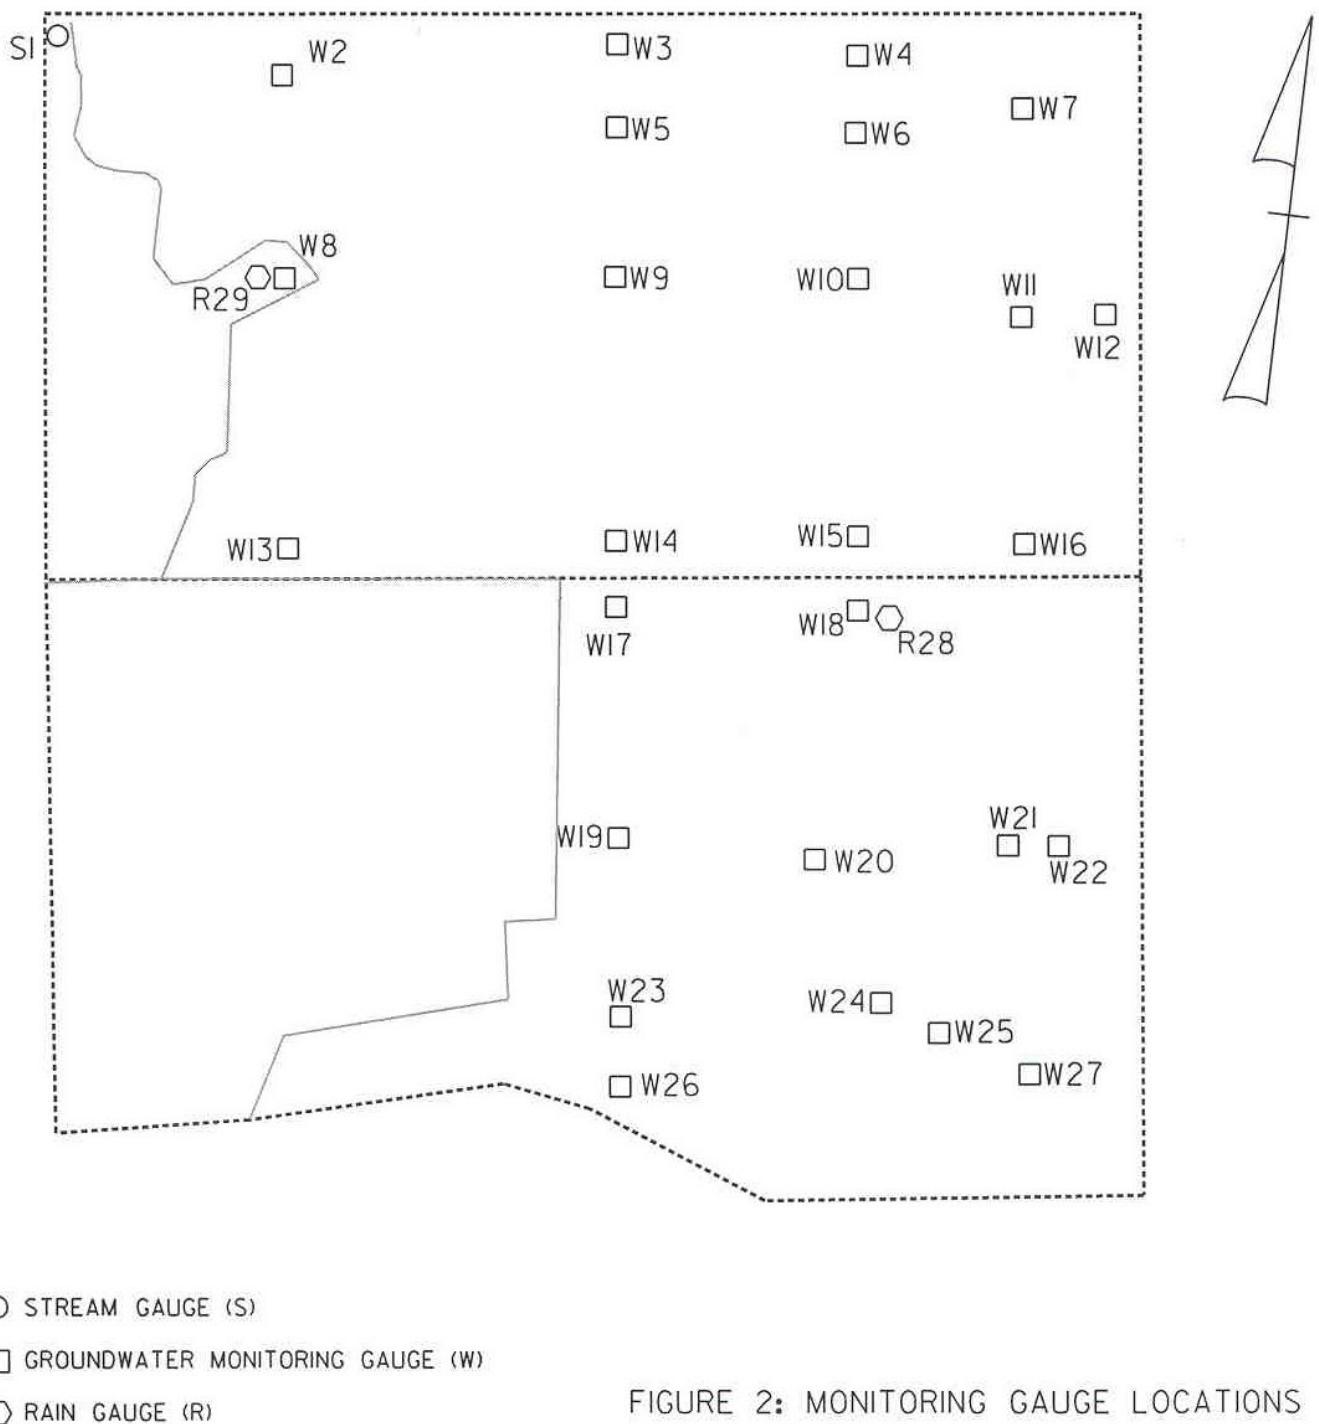
FIGURE 2: MONITORING GAUGE LOCATIONS

Twenty-six groundwater-monitoring gauges, two rain gauges, and one surface water gauge were installed on site in 1997 (Figure 2). The monitoring gauges record daily readings of groundwater depth. The rain gauges were replaced in spring 2000 with infinity rain gauges.

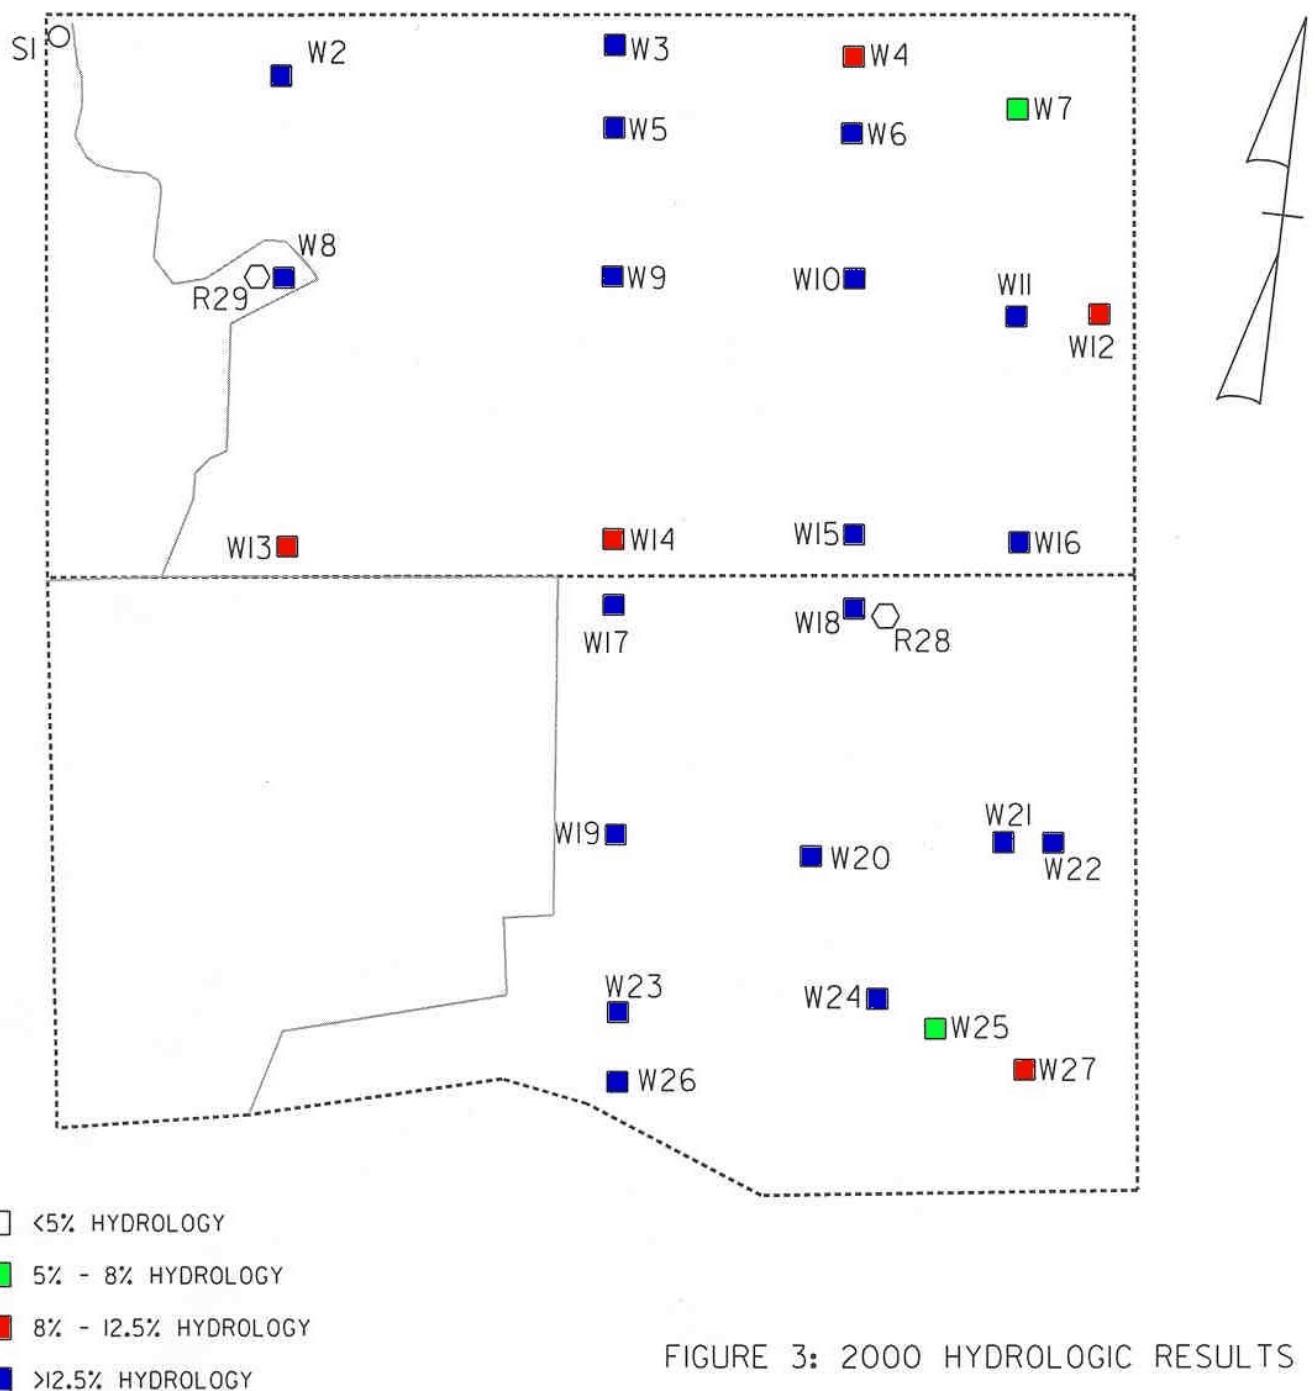
FIGURE 3: 2000 HYDROLOGIC RESULTS

Figure 3 is a graphical representation of the 2000 hydrologic results. A blue dot indicates hydrology for greater than 12.5% of the growing season; a red dot means the gauge showed between 8% and 12.5%. A green dot indicates hydrology between 5% and 8% of the season. It is this hydrologic data which will determine the success of the site. The surface water gauge has recorded appreciable surface water throughout the growing season.

The data for the 2000-growing season indicates that nineteen of the twenty-six monitoring gauges met the success criteria. Gauges 4, 13, and 14 did not meet their expected hydrologic criteria while many of the gauges met well above expectations. Gauge number 4 registered within the success criteria for 12.1% of the 2000-growing season and has shown significant improvement over the 1999-growing season. Gauges number 13 and 14 are located along the area where the large canal was filled in across the middle of the site. Gauge 14 has shown some improvement while gauge 13 continues to meet success criteria only around 8.2% of the growing season. It has been noted that even though gauge 13 lies near the floodplain area, no ponding is occurring at this location.

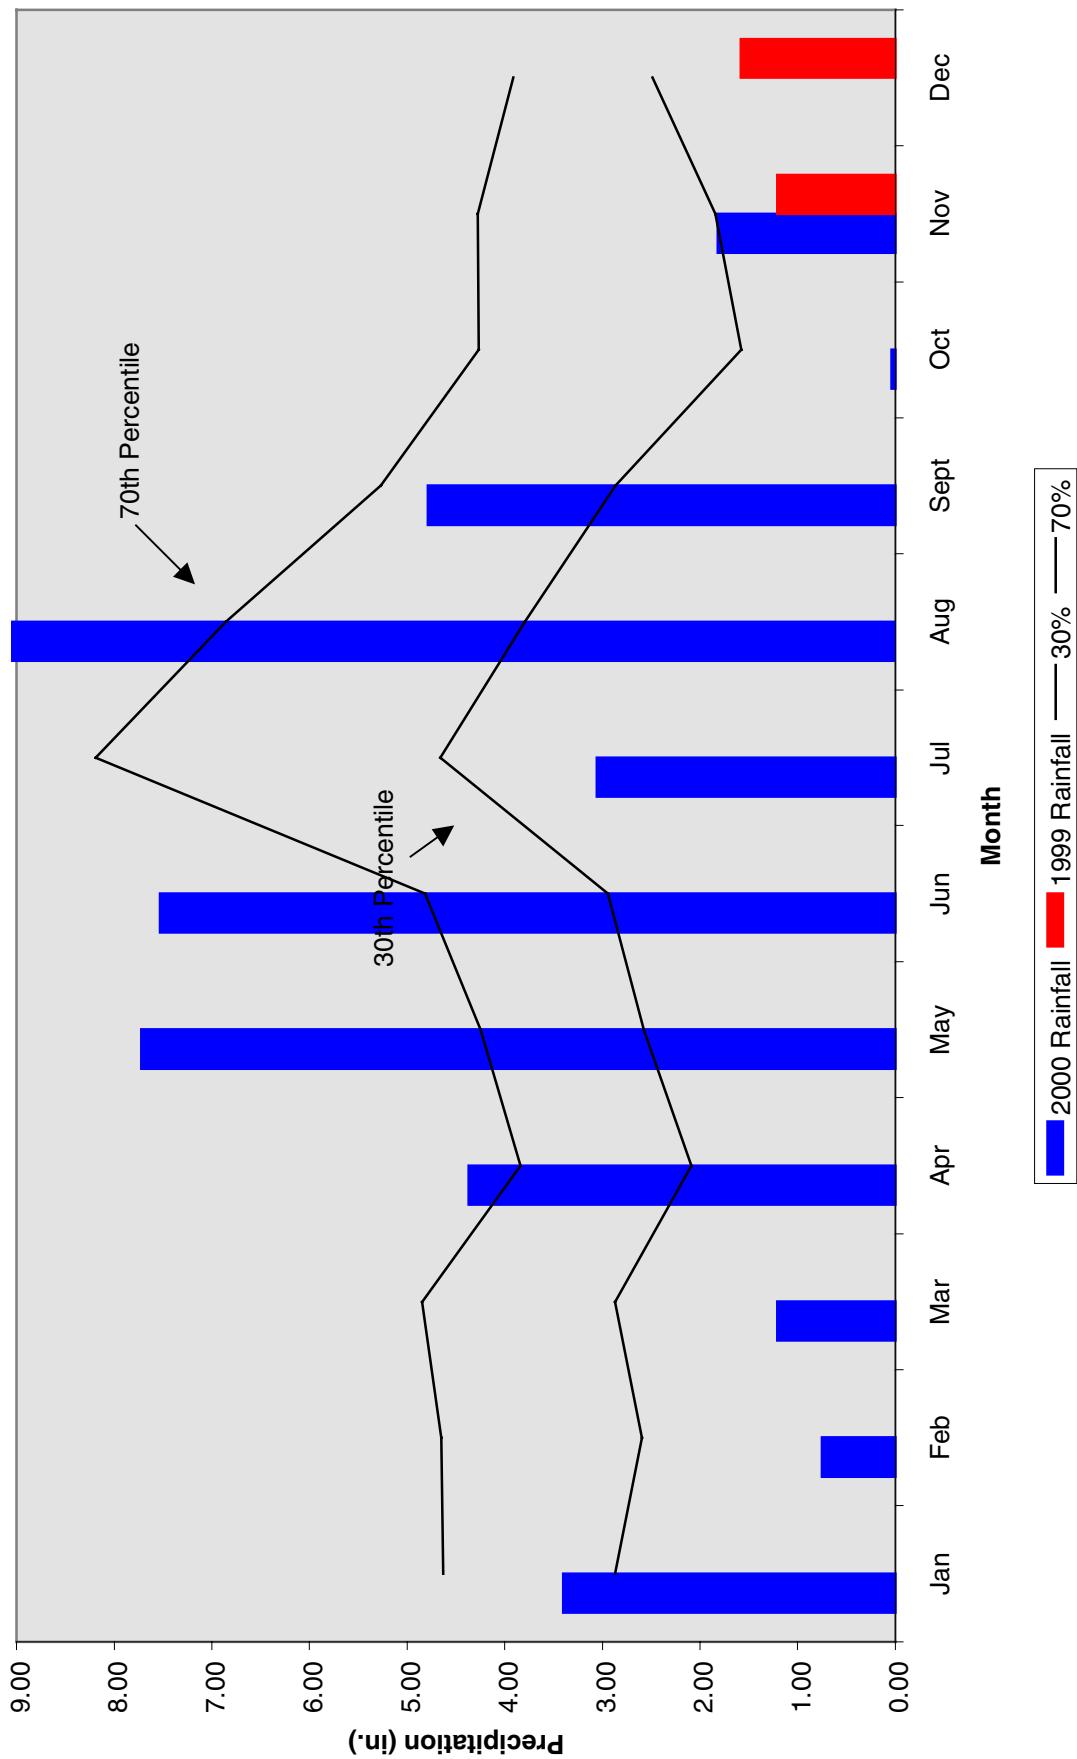
Figure 4: Dismal Swamp 30-70 Percentile Graph

Figure 4 is a comparison of 1999 and 2000 monthly rainfall to historical precipitation for the area. The two lines represent the 30th and 70th percentiles of monthly precipitation for Elizabeth City, NC. These percentiles represent monthly rainfall data collected between 1931 and 1998 from a National Climatic Data Center rain gauge. The 1999 and 2000 monthly rainfall data was provided by the State Climate Office of North Carolina at NC State University. Because of data availability, the 2000 rainfall encompasses precipitation through November 2000. The 2001 annual report will include a 30-70-percentile graph with the monthly rainfall from November and December of 2000.

Rainfall for the Elizabeth City vicinity in the past two years ranges from below average to above average.

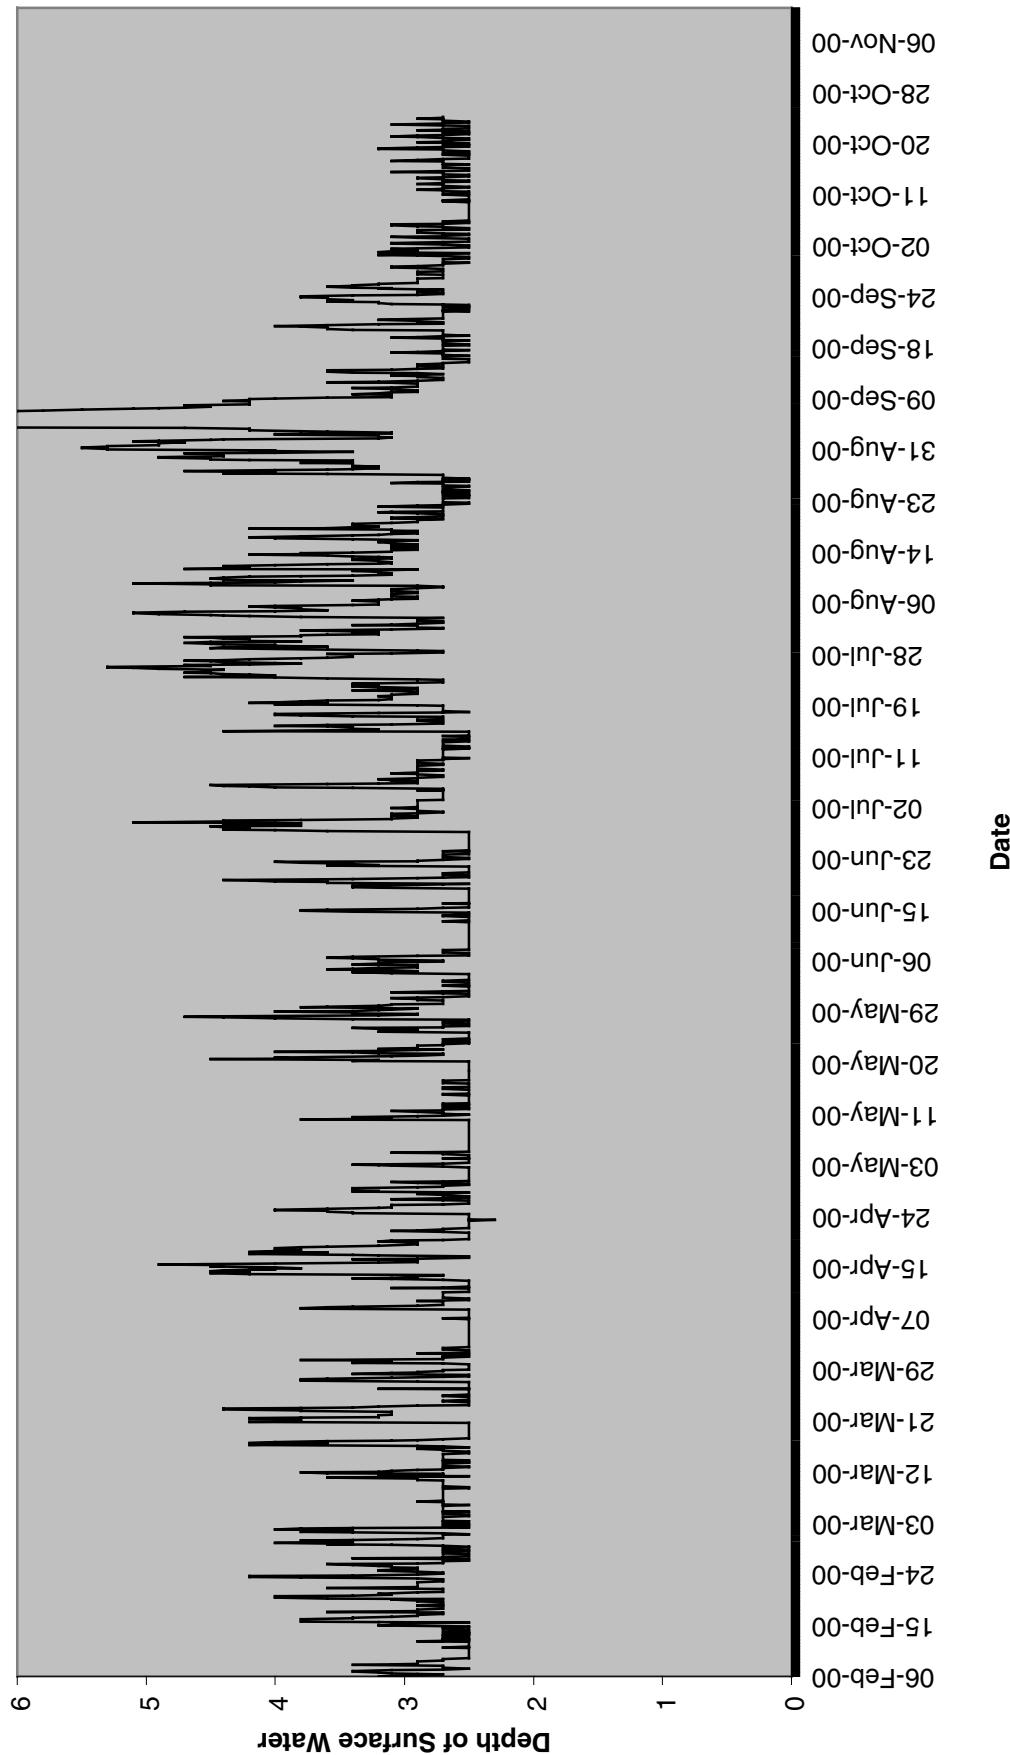
**Dismal Swamp-W1
Surface Gauge**

Appendix A contains a plot of the groundwater depth for each monitoring gauge. Data determined to be erroneous was omitted; therefore, some gaps appear in the plots.

Precipitation events are included on each graph as bars. The rainfall plotted was obtained from the on-site infinity rain gauge.

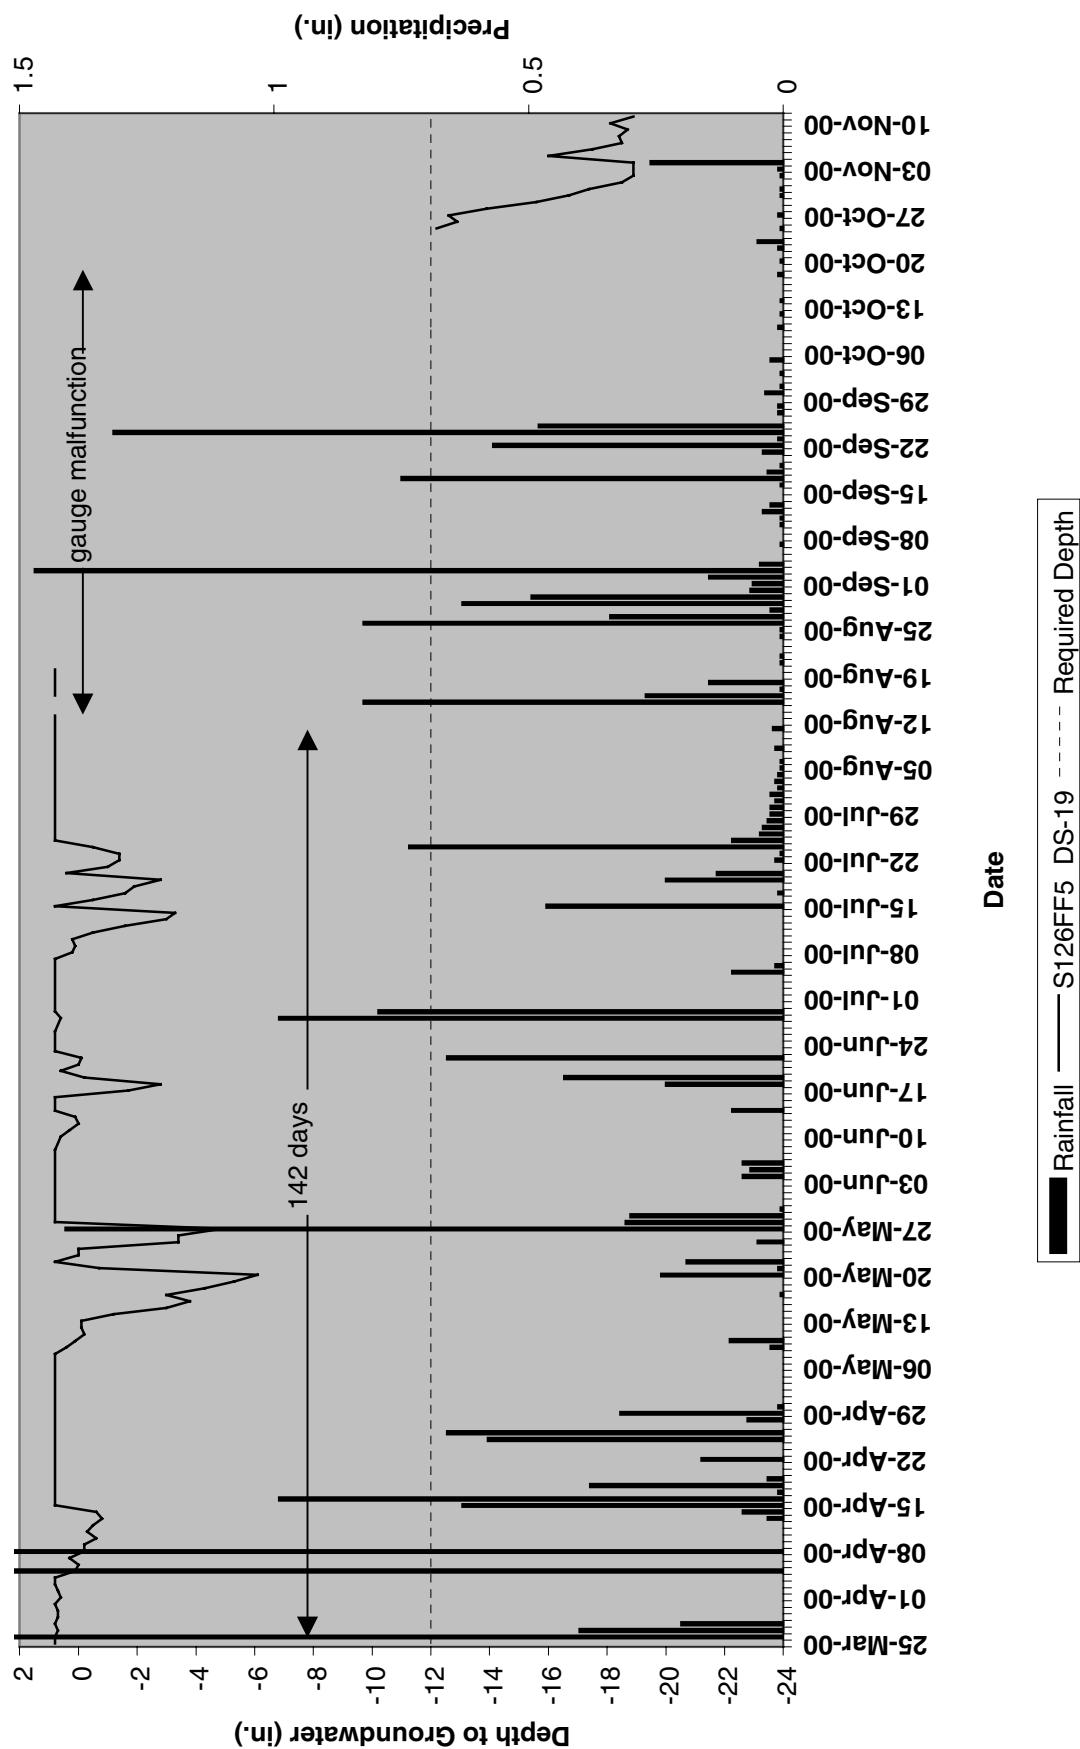
Dismal Swamp-G19

Gauges 19 and 20 displayed several difficulties during the growing season due to dead batteries. Each time the batteries were replaced and the gauge reset. Gauge number 20 was removed and replaced during the November download.
